EARTHQUAKE GROUND EFFECTS DURING MODERATE EVENTS: THE L'AQUILA 2009 EVENT CASE HISTORY

Abstract: On April 6th, 2009, a M_w 6.3 earthquake rocked the town of L'Aquila (Central Italy) and surroundings, inducing a noteworthy number of effects on the environment. Earthquakes with M_w between 6 and 6.5 are of relevant interest in the Mediterranean Region because of their frequency and their consequences in this densely populated area. The L'Aquila event is representative of the geological effects to be expected: ca. 200 effects on the environment have been recognized, allowing us to estimate an epicentral intensity IX, by applying the ESI 2007 scale. The post seismic evolution of some ground fractures is under monitoring, in particular along the reactivated Paganica fault.

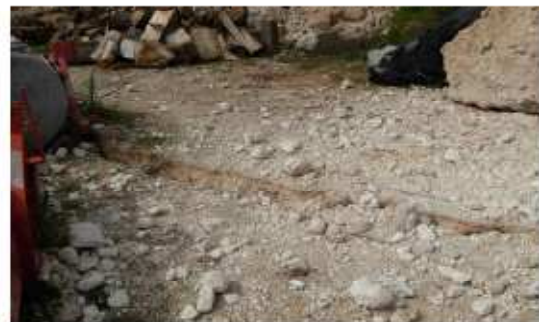
Fig. 5: The Paganica ruptures were traced in the ground, across buildings and concrete roads, more or less continuously, for at least 2.6 km with offsets up to 7-8 cm, which locally continued to increase in the following weeks

A set of discontinuous but well aligned ground ruptures was found in correspondence of the Paganica fault (yellow arrow in Fig. 2). These ruptures, trending between N120 and N140, could be traced for a length of at least 2.6 km, reaching in some sites vertical offsets of 7-8 cm (Fig. 5). They could be easily observed on paved/concrete and often dirt roads and on other artificial surfaces, as well as on buildings and hard fences. Particularly evident was the pipeline rupture of the Gran Sasso aqueduct (Fig. 6). The same set of fractures was locally well evident also on natural/farmed soil.

These ruptures are a clear evidence of coseismic surface faulting. This interpretation is in good agreement with the seismological data (distribution of aftershocks, focal mechanisms) and with the coseismic field of deformations resulting by the comparison of pre- and post- event SAR images.

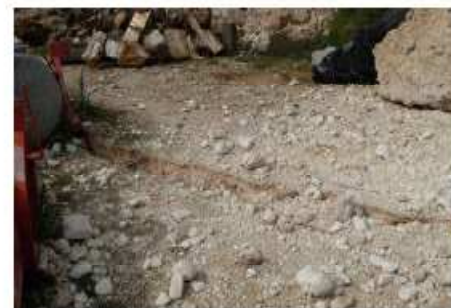
Fig. 5: The Paganica ruptures were traced in the ground, across buildings and concrete roads, more or less continuously, for at least 2.6 km with offsets up to 7-8 cm, which locally continued to increase in the following weeks.

A set of discontinuous but well aligned ground ruptures was found in correspondence of the Paganica fault (yellow arrow in Fig. 2). These ruptures, trending between N120 and N140, could be traced for a length of at least 2.6 km, reaching in some sites vertical offsets of 7-8 cm (Fig. 5). They could be easily observed on paved/concrete and often dirt roads and on other artificial surfaces, as well as on buildings and hard fences. Particularly evident was the pipeline rupture of the Gran Sasso aqueduct (Fig. 6). The same set of fractures was locally well evident also on natural/farmer soil.

These ruptures are a clear evidence of coseismic surface faulting. This interpretation is in good agreement with the seismological data (distribution of aftershocks, focal mechanisms) and with the coseismic field of deformations resulting by the comparison of pre- and post- event SAR images.

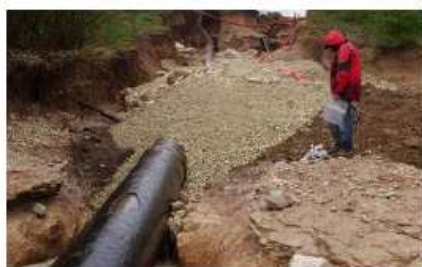
Fig. 6: The site where the aqueduct was broken by coseismic faulting

The coseismic reactivation of the Paganica fault caused the rupture of the Gran Sasso aqueduct. The very high pressure of the water flowing from the damaged pipeline

excavated a deep trench, thus providing extraordinary exposures of faulted sediments and unequivocal evidence of previous, larger, coseismic surface faulting events.

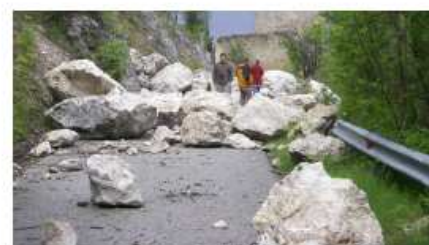
Fig. 8: Fossa rockfall: huge boulders on a paved road

them, one of the most impressive falls took place above the village of Fossa, which was directly damaged by huge boulders (Fig. 8). Residual risk of rock falls caused the temporary closure of some important roads.

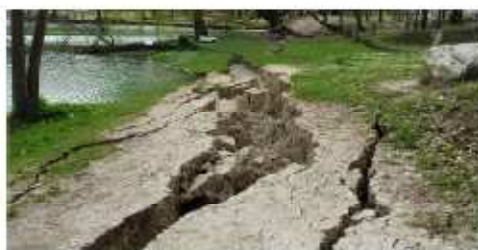
Fig. 9: Ground failures along the shore of Lake Sinizzo

Other types of slope movements, generally affecting artificial fills, occurred along several roads, including the highway A24. Around the Lake Sinizzo, near San Demetrio ne' Vestini, impressive ground failures along the whole shoreline were observed (Fig. 9). In the other sinkholes of the area (generally empty of water) no remarkable effects were found.

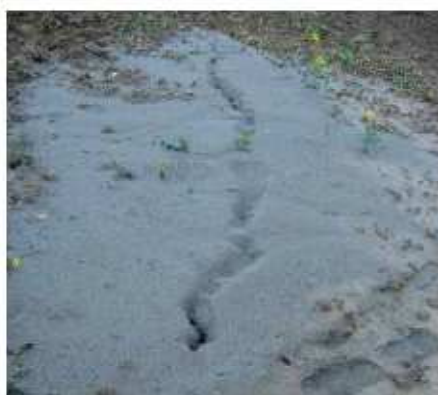
Fig. 10: Mud/sand volcano near Vittorito (courtesy by G. Pipponzi, AdB Abruzzo)

The only remarkable liquefaction feature was found by the geologists of the Abruzzo River Basin Authority at Vittorito (near Sulmona), hence relatively far from the epicenter (Fig. 10).
