The Apsidal Building of the *Vicus Martis Tudertium* (PG)

John Muccigrosso – Sarah Harvey – Elena Lorenzetti – Jill A. Rhodes – Stefano Spiganti

Over the course of the past three seasons (2012-2014) at the putative site of the *Vicus Martis Tudertium* near the church of S. Maria in Pantano (Massa Martana, PG), excavation has focused on a large structure first observed in crop marks in fall 2008. We have uncovered a large building oriented along the putative *Via Flaminia* and possessing an apse at its eastern end, the precise function of which remains unclear. Excavation has also uncovered a series of early-medieval burials located just east of the structure.

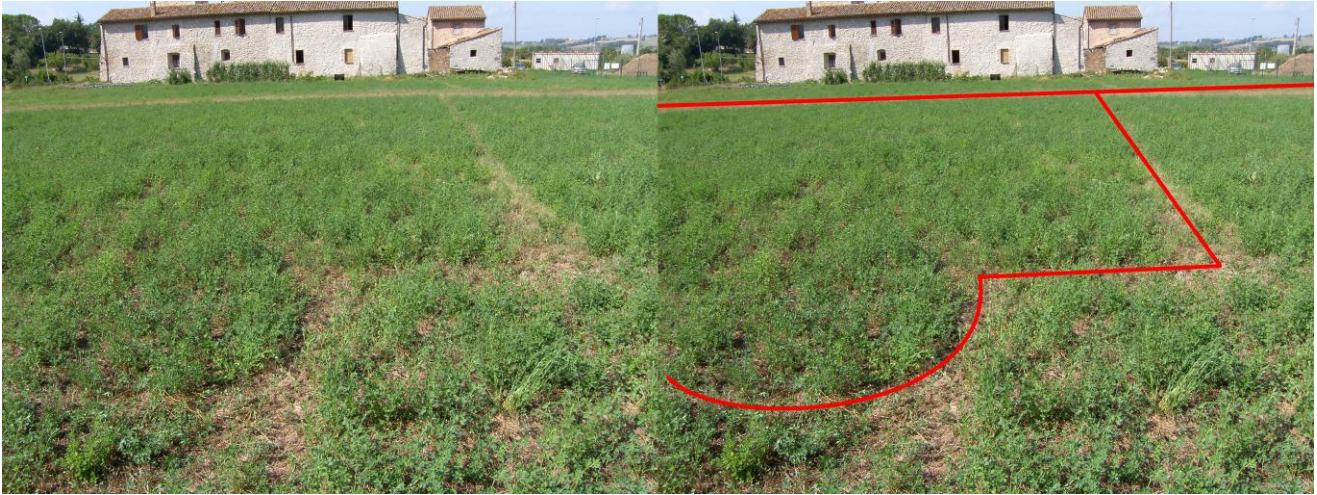
Fig. 1. Crop marks, looking west. The horizontal line in the distance, closer to the building complex around the church of S. Maria, shows the course of the road. (Photo C. Zoccoli).

The presence of remains close to the surface, coupled with the planting of alfalfa in recent years, has resulted in the frequent visibility of crop marks in the fields around the church of S. Maria. Most noticeable on satellite images of the kind available on numerous websites is the N-S-running road that we have identified as the original course of the *Via Flaminia*. No doubt due not only to the shallow depth at which it lies, but also because of its width (~4m), the effects of the road may be seen with other crops that are less likely to show such marks. Late in the summer of 2008, after our first season of excavation, an unusual set of marks were visible in the area to the east of the church and the road, reaching the limit of the *particella* in which we were working. The crop marks (fig. 1) seemed to outline a semi-circle, opening to the west and with its end points connecting to and forming right angles with a straight N-S running wall on each side. These two walls in turn connected to and formed a corner with two longer walls which ran west, culminating close to the road. The semicircular wall and the plan of the structure indicated that in all likelihood this was an apse. We therefore turned our attention to this area for three seasons (2012-2014).

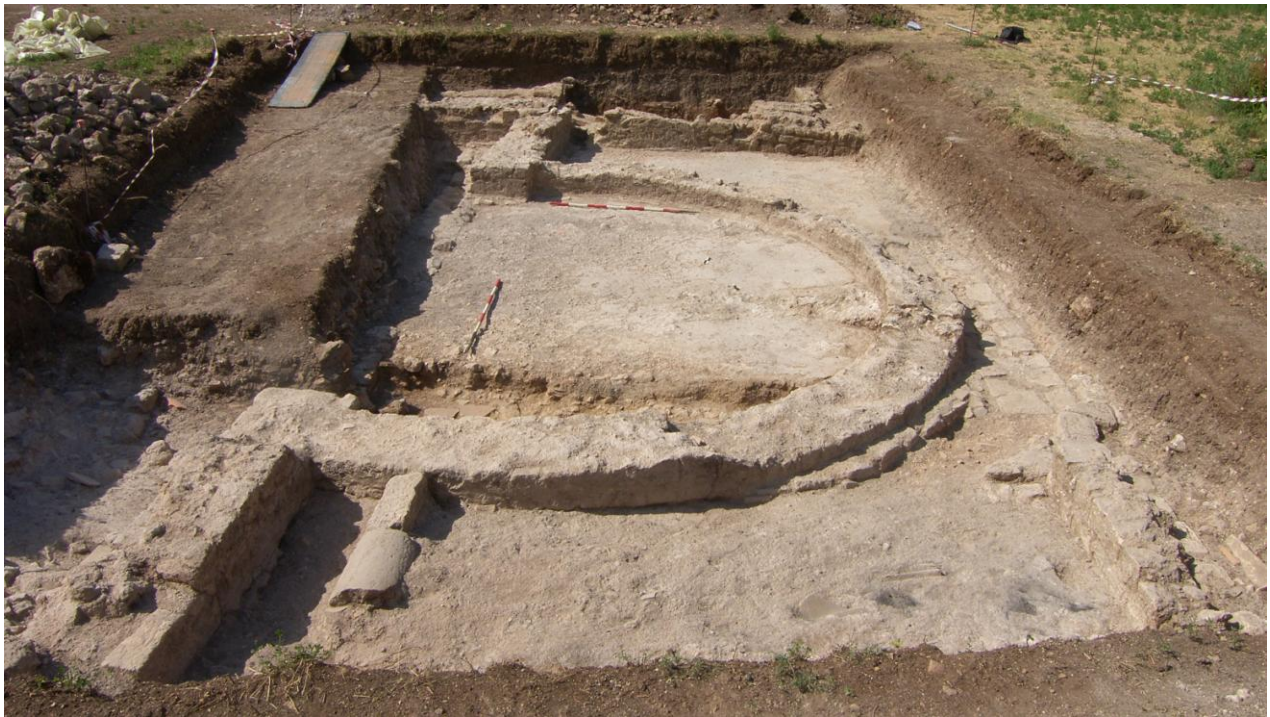
Fig. 2. Apsidal structure at the end of the 2012 season, looking north.

Apsidal building – Excavation quickly confirmed the presence of an apsidal structure (fig. 2) with overall measurements of ~24m x 10m, and further investigation over the three seasons revealed the existence of several phases of construction. The curved portion of the apse itself (711), some 6m in diameter, appears to have been constructed immediately upon a pre-existing floor (identified as 721 in the interior of the apse, and 750

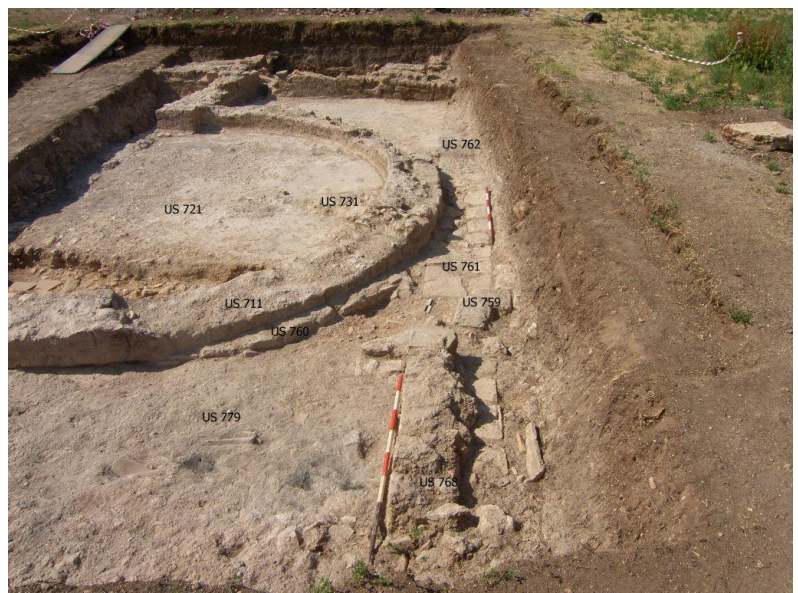
Fig. 4. Aligned features immediately east of the apse after the 2012 season.

outside the apse to the northeast). (See the plan in fig. 3; fig. 4.) Immediately to the east, a feature running roughly N-S (**761**; dark green on the plan) lies flush with this pavement. Its surface is composed in its center of stones along with tile and amphora fragments; further north the surface transitions to a rough *cocciopesto*. The extreme eastern edge of the apse rests on **761**. Moving southward, after a short break (due at least in part to a later burial **941**, about which see below), a damaged section of wall (**768**) lies in line with **761** (fig. 4). To the west and parallel to these features is an earlier wall (**740** and **736**; yellow), lying partially underneath the N-S wall segments from which the apse springs. It (and so **761**) runs with a different orientation from the apsidal structure. Although complete excavation of this fea-

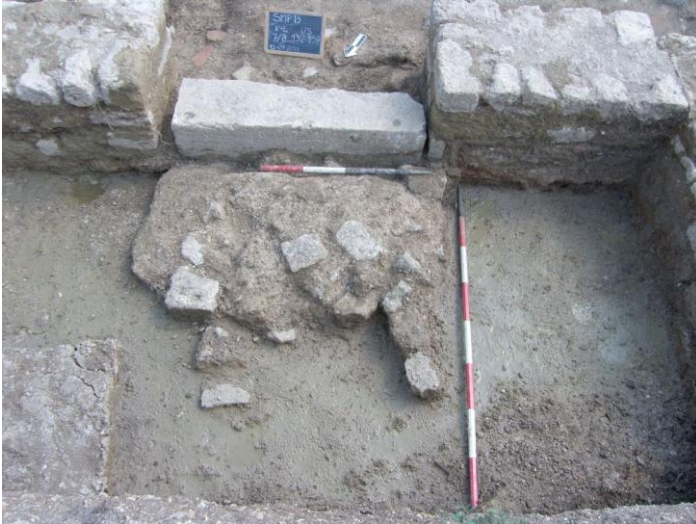
Fig. 5. Threshold stone **932** with floor preparation **957**.

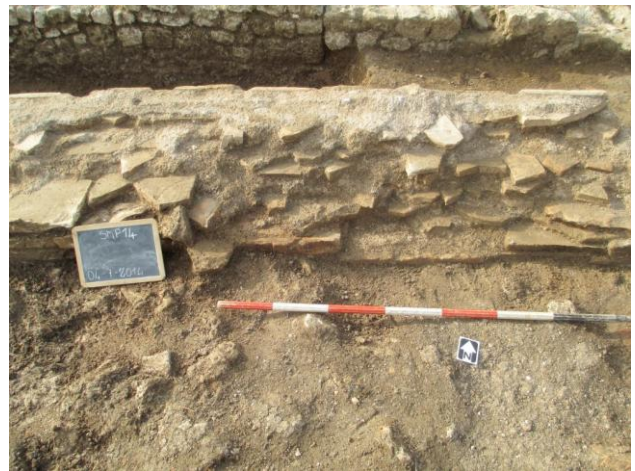
Fig. 6. **1029** from the south, showing the many tile fragments in the wall with the flanges of the top layer forming the northern face. **1016** is visible at top.

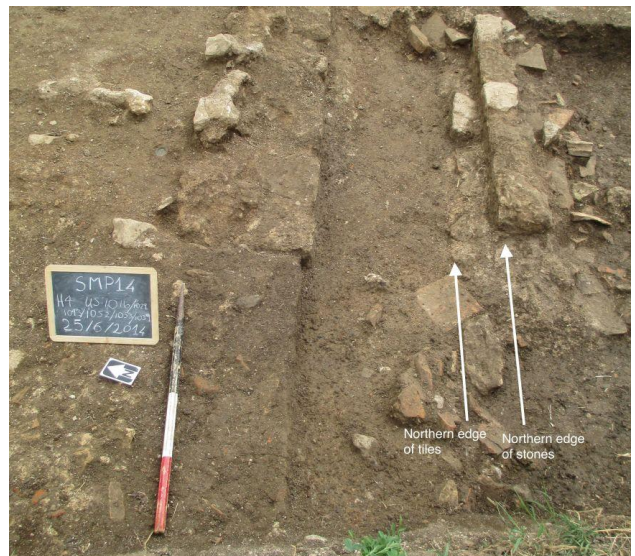
Fig. 7. Small ashlars on the tiles of **1029**.

tiles (fig. 7). Evidence for this placement of the stones is also visible in the mortar in other portions of the wall. The southern face of **1029** is much more poorly preserved than the northern. This likely reflects the way in which the stone wall just to the north (**1016**; light green) protected that face from the damaging action of the plow.

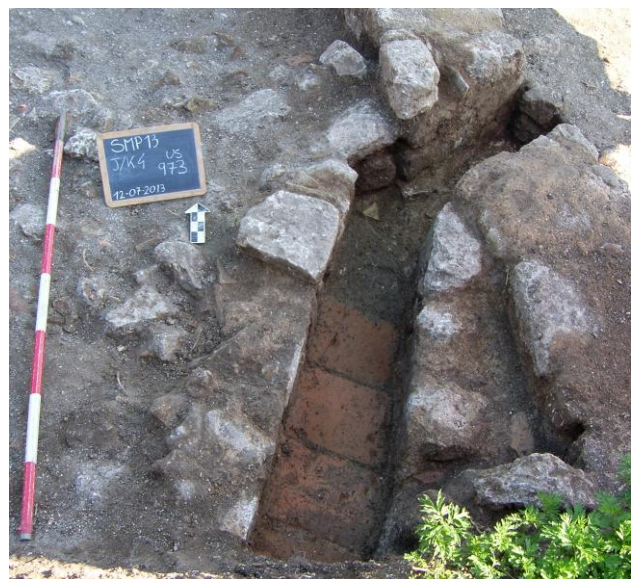
Fig. 8: Drainage channel **973**.

First is the small drainage channel (**973**) built into the western wall of the structure, creating the division between the N-S running walls **975** and **976** (fig. 8), and, based on its slope, leading out of the interior. Its walls are composed of small flat-faced stone and its floor consists of bricks or carefully broken roof tiles. We were not able to determine whether it connected to any additional structures in the interior or exterior.

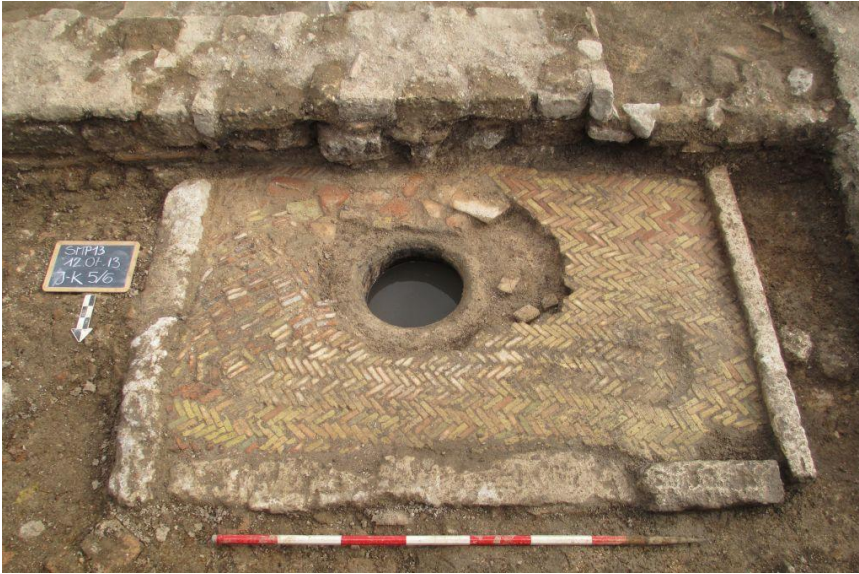
Fig. 9. Well or storage feature with surrounding pavement **983**.

A partial break in **919** is related to the presence of an opening (~35cm in diameter) to a well or buried storage feature just inside and to the north of that wall (**983**, fig. 9)⁵. The mouth of the feature is made of a monolithic circular stone and a surrounding rectangular area is paved mainly with small bricks in a herringbone pattern. This *opus spicatum* floor fragment is itself bordered by limestone curbing of inconsistent size and shape, likely repurposed. It is worth noting that the herringbone pattern is not aligned with the wall, which in fact partially overlies the floor's southern edge. Additionally the herringbone shows signs of multiple repairs, partly with similar bricks aligned in a different pattern, partly with irregular fragments of tile or brick. All this suggests that the feature was present relatively

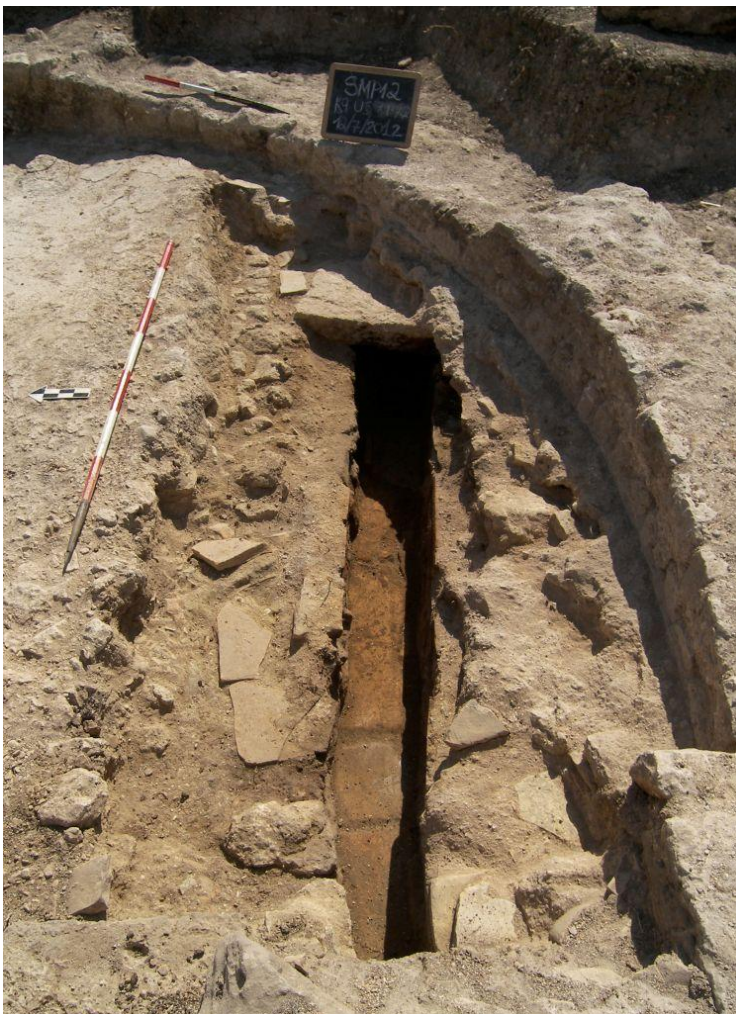
Fig. 10. Exposed drainage channel underneath the floor of the apse.

A second, larger drainage channel (**749**) is present inside the apse itself, running from west to east, from the interior of the rectangular area under the floor of the apsidal area (fig. 10). The floor of the drain is composed of brick or tile, and the sides of brick, tile and small stones mortared together. The drain was covered with heavy, thick stones, at least one of which appears to be a reused paving stone, and these were in turn covered with roof tile fragments and flat stones to make the final surface flush with the rest of the apsidal area. It is not clear whether the floor was dug out to create this feature, or the floor ended here at another pre-existing structure. Possibly then the channel pre-dates the apse. The interior of the channel was mainly empty and the small amount of soil it contained was sterile. The eastern end of the drain appeared to be blocked, but extending its line leads to a break at the northern end of short section of the short wall **768** (green on the plan), where a series of finished stones were found surrounding a burial (**987**; see below, including fig. 18). Because of the curved shape of the stones, it is tempting to think that these once formed part of the opening for a well or other storage feature.

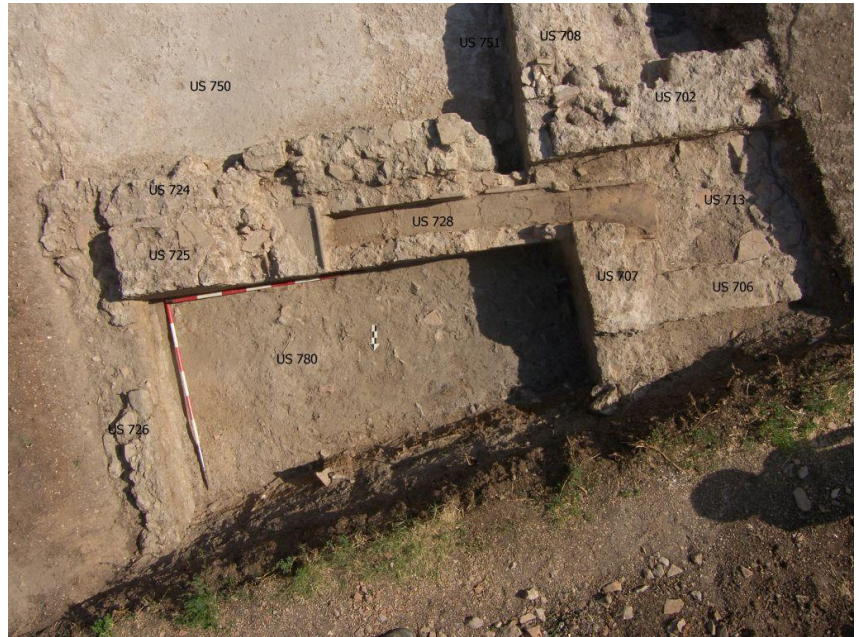
Fig. 9. Well or storage feature with surrounding pavement **983**. Fig. 11: Overhead view of the drain formed by roof tiles.

another feature, **725** (fig. 11). The entire structure included a kind of collection area to the north of **702**, the surface of which was formed from mortared tiles and perhaps originally coated for waterproofing (**713**). The drain **728** was made of roof tiles, placed one inside the next, and covered by another series of tiles held in place by a course of stone and placed at right angles to the channel's base tiles. (See the flange on the partially exposed tile, running vertically in fig. 11 at the easternmost portion of **728**.) Perhaps water was collected from the roof or from building interior (though the surface of the collecting area lies some 30cm higher than the herringbone pavement of the well area). **725** must form part of another collection feature or provide a further route to one. It also seems likely that the western portion of the channel was covered as the east still is.

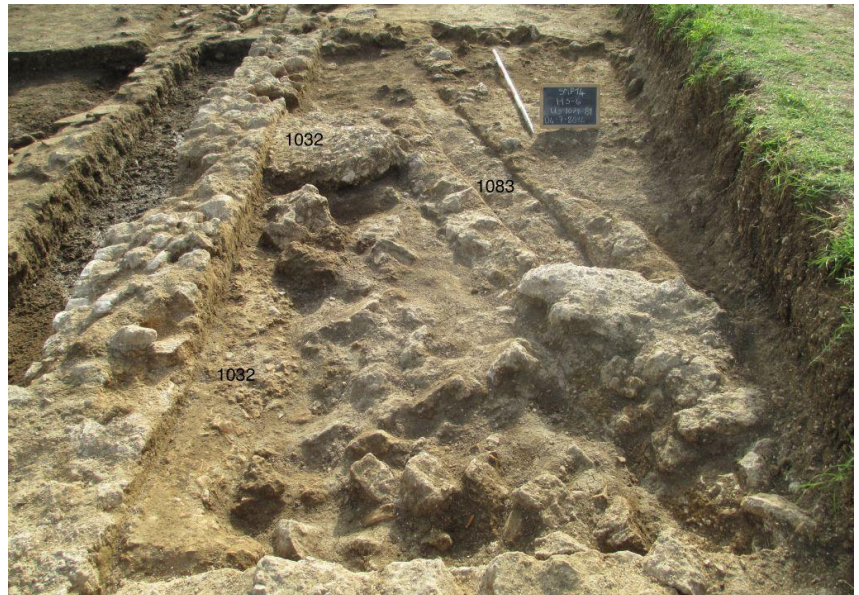
Fig. 12. Area lying to the north of the apsidal building, showing pavement at a higher elevation. North to right.

North of the apsidal structure
– As is evident from the plan in fig. 3, we (partially) uncovered several nearby structures in addition to the one discussed at length here. These

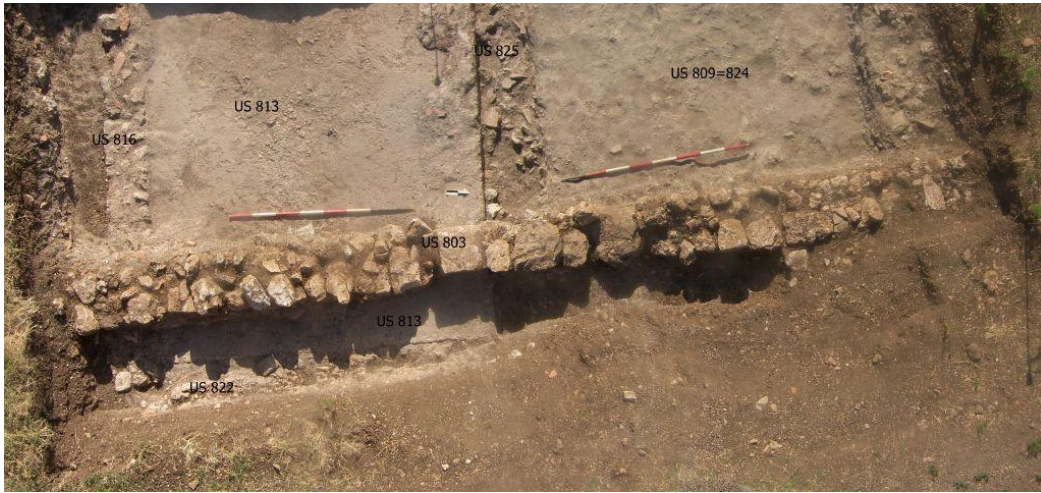
Fig. 13. Area to the south of the apsidal building showing significant spoliation.

Abandonment and Spoliation – Previous seasons of excavation have provided evidence that the *vicus* was heavily despoiled after its abandonment. An area just to the south of the apsidal structure offers a particularly clear example.

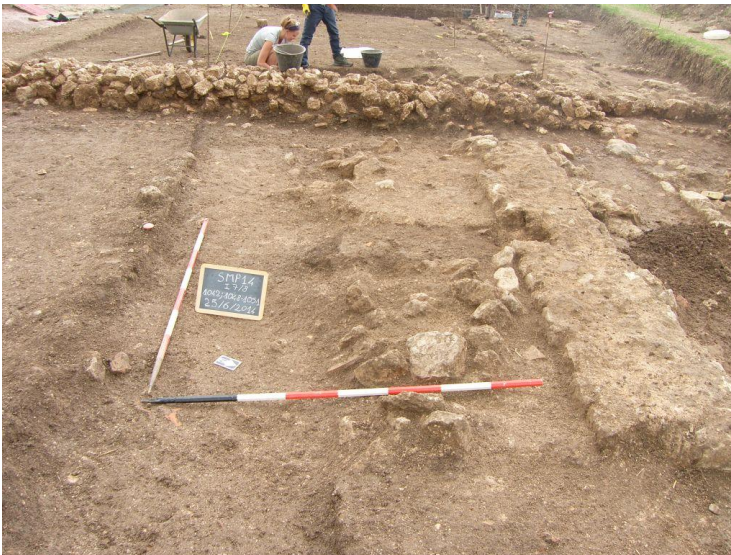
Fig. 14. Top of 1051 in the foreground with 903 at top (west).

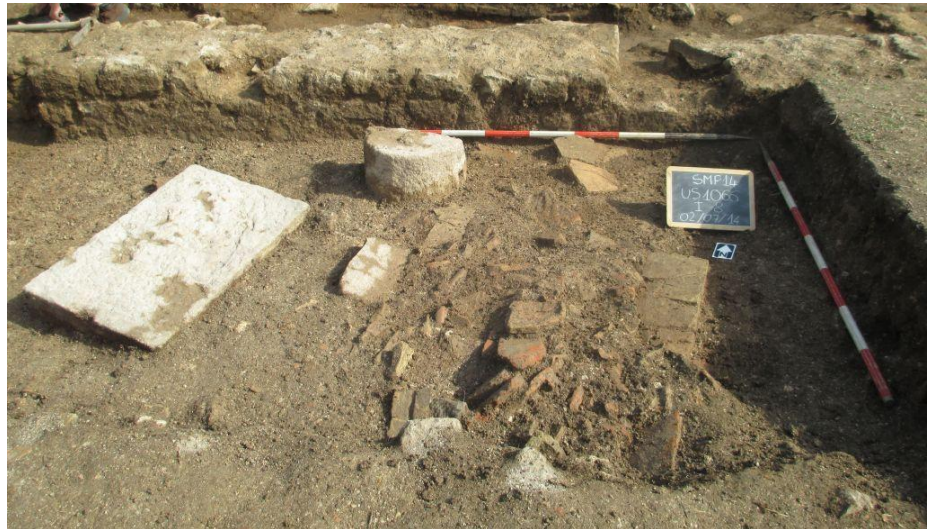
Fig. 15. Three large items resting inside the apsidal structure to the south of **706** and west of **903** (not shown).

and the other a portion of a stone column, along with a series of ca. 10 bricks, likely the remnants of a pavement, but like the other pieces, out of its original position. This whole accumulation appears to be an intentional dump of material into the interior of the then out-of-use structure. The best evidence for the chrono-

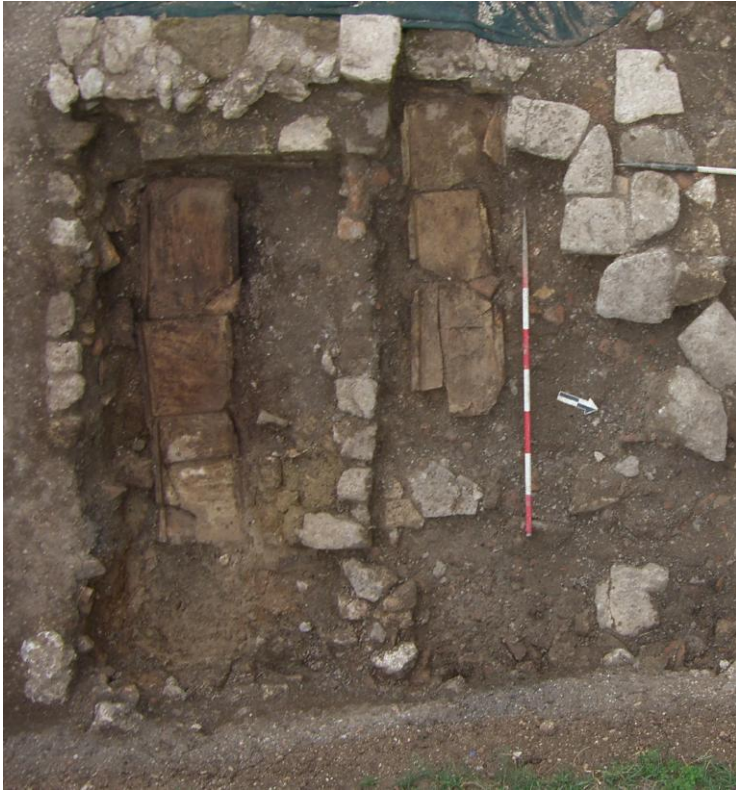
Fig. 16: Side by side burials of **963** and **987** after excavation, showing preserved surrounding stones.

Burials 963 and 987 – These two burials, a *cappuccina* style, as those from previous years were, and with their heads to the west, were located side by side to the east of the short portion of a wall, **768**. Burial **963** lies immediately to the south of **987**. Both were disturbed after deposition, though much less so than the previous burial. In particular a heavy stratum (**938**) containing much fragmentary tile, pottery, wall plaster, *tubuli*, and other debris covered the preserved eastern portion of both burials. In addition the easternmost of the three pairs of covering tiles of both were absent, and the remaining covering tiles of **987** were heavily damaged. Both burials may have been originally surrounded by stones (many of which are now lost, creating the uncertainty), including in the case of **987** some with worked sides suggesting they originally formed part of another structure (fig. 16).

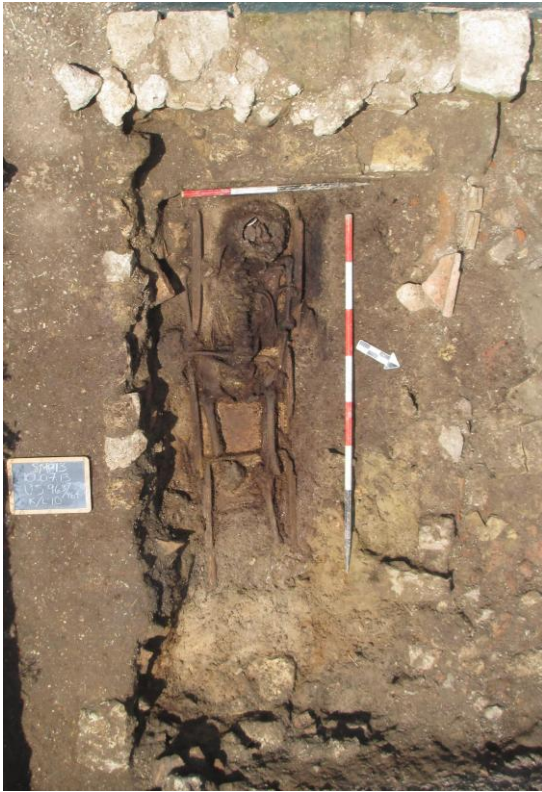
Fig. 17. Burial 963 in situ.

Burial **963** contained the largely complete remains of a large, robust male 60 or more years of age (fig. 17). He suffered from advanced osteoarthritis of the vertebral column, and had signs of osteoarthritis in the hips, shoulders, right elbow, right wrist, and left knee. He had significant tooth loss, calculus deposits on his teeth, and advanced periodontal disease. He also had a very well healed fracture of the right ulna that shows signs of medical treatment as there is no shortening, displacement or secondary infection.

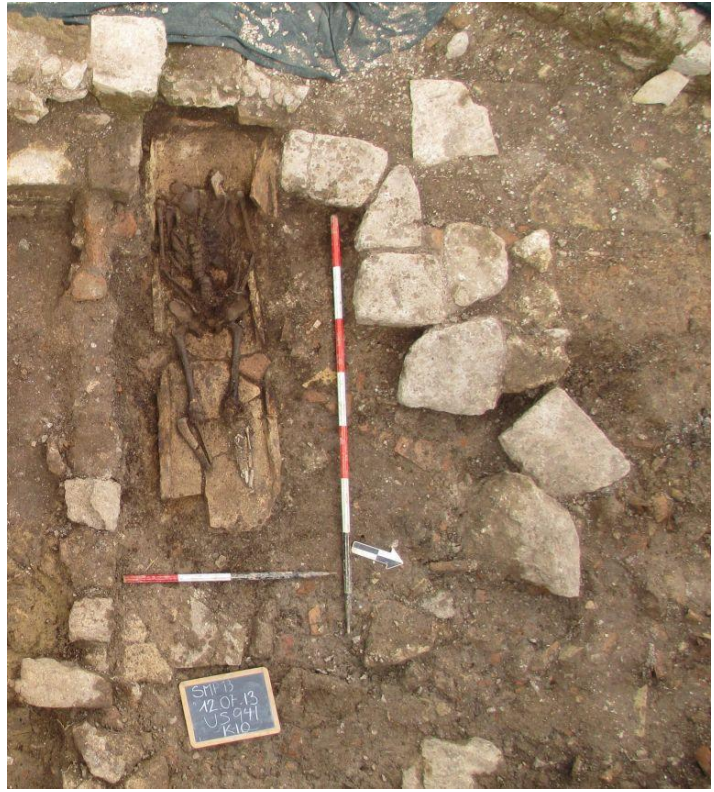
Fig. 18. Burial 987 in situ, showing the finished stones which perhaps formed part of its northern border.

Burial **987** contained the remains of a female, approximately 16-18 years of age (fig. 18). Preservation was generally good, though not as good as **963**; less than 75% of the skeleton remains. Absent elements include most of the skull, part of the left leg and both feet. She had dental caries and a hypoplastic defect in one

tooth that indicates a period of severe ill health or physiological stress at 7.5–8 years of age. The westernmost tile (under the upper body) appears to have been placed immediately to the north of wall 768. To the north at least some of the finished stones near this end of the burial appear to have been disturbed (visible in fig. 18), but the westernmost are shaped and situated as to suggest that they formed a corner, perhaps the border of an opening of some kind related to the drainage channel 749 (see above). This burial provides our only sure example of a grave good (see below). A bone sample was submitted for radiocarbon dating to the “Centro di Datazione e Diagnostica” (CEDAD) of the University of Salento. The analysis gave a 95.4% probability that the burial dates to the 540–670 CE, and a 68.2% probability of it dating to the shorter range of 590–660⁹. The results from two other burials from elsewhere on the site (to be published) overlap with this range. This dating is consistent with the analysis of artifacts from the site, which generally do not date later than the 4th c. CE, and suggests that the burials were placed after the major period of occupation of the *vicus* had ended.

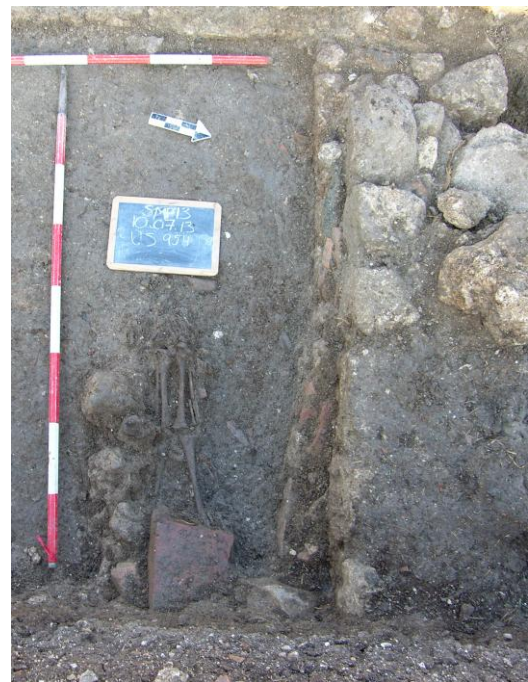
Fig. 19. Burial 954 in situ. 920 is visible to the right, and the eastern edge of 761 at top.

Burial 954 – A final burial was located to the north of the previous two, immediately south of and adjacent to the wall 920 (fig. 19). Forming the southern border of the burial is a line of stones, while a cover was provided using broken roof tiles. It is

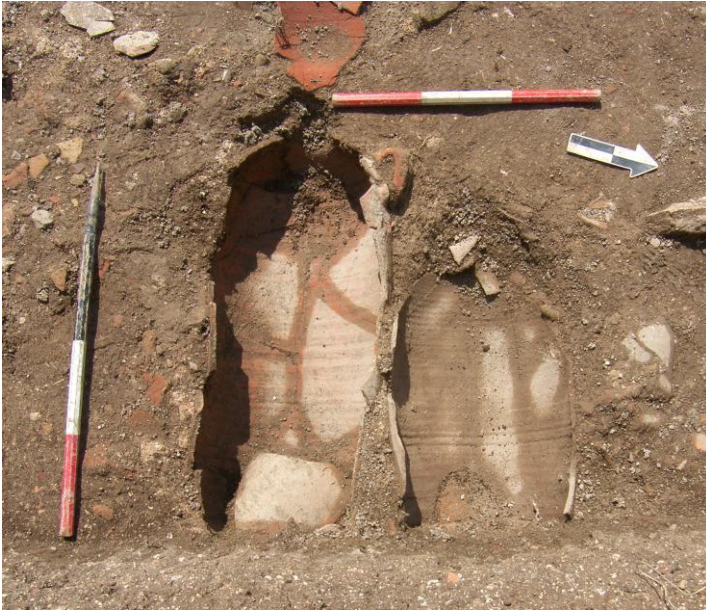
Fig. 20. Amphora halves **981** (right) and **1012** (left) in situ.

Amphoras 981 and 1012 – Lying in the floor of the trench to the south of burial **954** and also partly embedded in the eastern section were half (or less) of two amphoras (fig. 20). Given the proximity of the other burials, we

suspected that these might have been used for the burial of infants. Although the soil (clayey and white) they contained was different from that of the surrounding matrix, little material and no human remains were found in either of them.

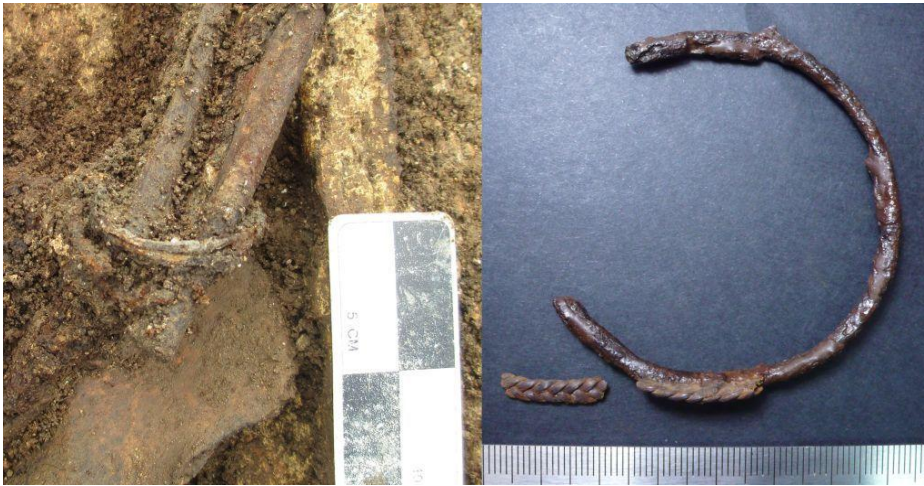
Fig. 23. Left: iron bracelet from **987** in situ; right: with remnants of braid, after conservation. Inv. 686267.

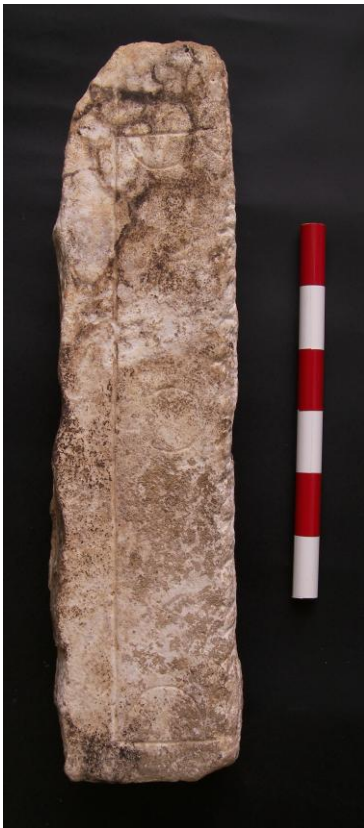
Fig. 24. Fragment of a game board. Inv. 703785.

An unusual find was excavated from a context of reuse. In the fill (**709**) for a drainage trench of a kind we have encountered throughout the excavated area of the site was discovered a fragment of a game board, carved into a paving stone (fig. 24). The stone had been reworked before being placed into the trench, as can be seen from the series of relatively neat chisel marks along the right edge of the current orientation in the figure. It is likely that the trench diggers encountered the stone, which had already been re-cut, and simply threw it back into the trench. This suggests that whatever pavement or building the stone had originally been a part of had been reworked and the stone reused for
