Ground effects of the MI 5.2, November 24, 2004, Salò earthquake, Northern Italy: a case study for the use of the INQUA scale

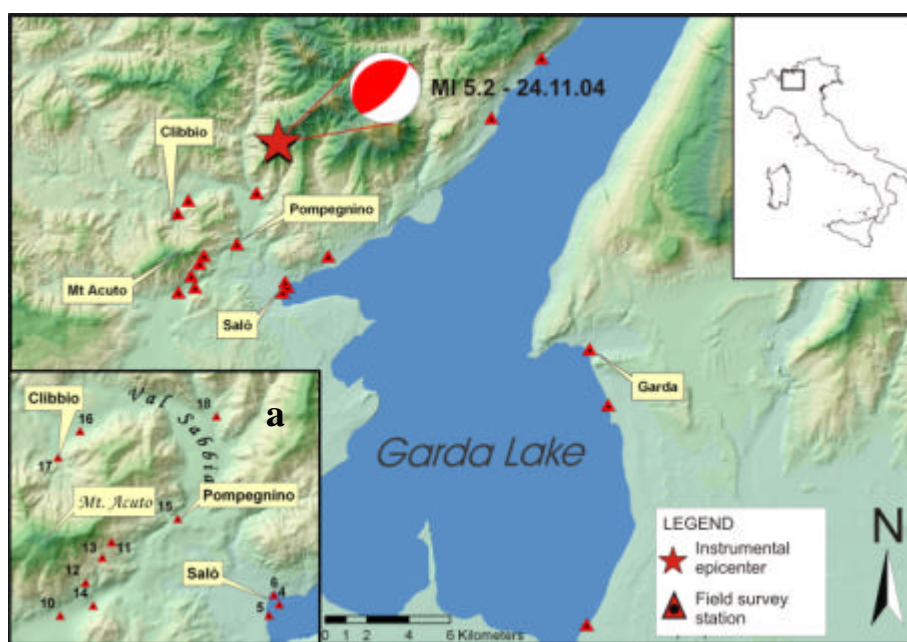
Figure 1: Digital elevation model of the study area including instrumental epicentre of the 24th November 2004 Salò earthquake (source INGV), focal mechanism (from the MEDNET Database) and the field stations where observations on coseismic ground effects have been collected. The inset box (a) shows a more detailed map of the epicentral area.

On November 24, 2004, at midnight (23.59 PM, local time), a moderate earthquake (MI 5.2, Mw 5.0; focal depth 8 km; source INGV, <http://www.ingv.it/terremoti/brescia2004/mecc-focale.html>) hit the Lake Garda region, within the active fold and thrust belt of the Southern Alps (Figure 1). This earthquake was felt in the whole Northern Italy, from Venice to Milan and Genoa, and abroad, for instance in Switzerland; the epicentral area includes the town of Salò and its surroundings, where where significant damage occurred and more than 200 people were left homeless. Epicentral intensity of VII-VIII in the MCS scale has been assigned in a preliminary way based on severe damage at the villages of Clibbio and Pompegnino.

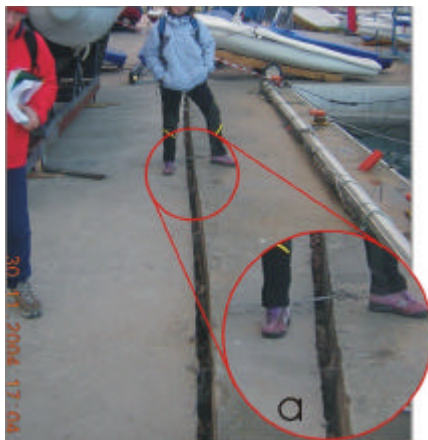
Figure 2: Fissure parallel to the waterfront, affecting the concrete in the Salò harbor area. This feature is an evidence of liquefaction and localized lateral spreading.

- Clibbio: along the Chiese River large rockfalls with dolostone boulders up to ca. 75 m³ detached from the mountain slope of Mt. Acuto; two houses were hit by the boulders, and the main road to Clibbio has been strongly damaged; new big rockfalls occurred also in the days following the mainshock;
- Pompegnino: several cracks on the ground and on the paved roads have been observed in the downtown area; these cracks show widening (from 1 cm to 2 cm) with time, especially after the strong rain occurred on Nov. 29 and 30, 2004;
- Salò: evidence of liquefaction and localized (over an area of ca. 500 m²) lateral spreading and settlement, with fissuring up to 30 cm wide parallel to the waterfront area have been observed in the harbor (Figure 2); these effects replicated those occurred during the 1901 event.

In general, most severe environmental effects and damage to buildings occurred in the same areas, and intensity assessed from the MCS scale is in good agreement with intensity assessed with the INQUA scale. From our data, INQUA intensity of VIII should be assigned to Clibbio and Salò, and VII to Pompegnino.
