Small bowel obstruction caused by mesh migration. Case report

SUMMARY: Small bowel obstruction caused by mesh migration. Case report.

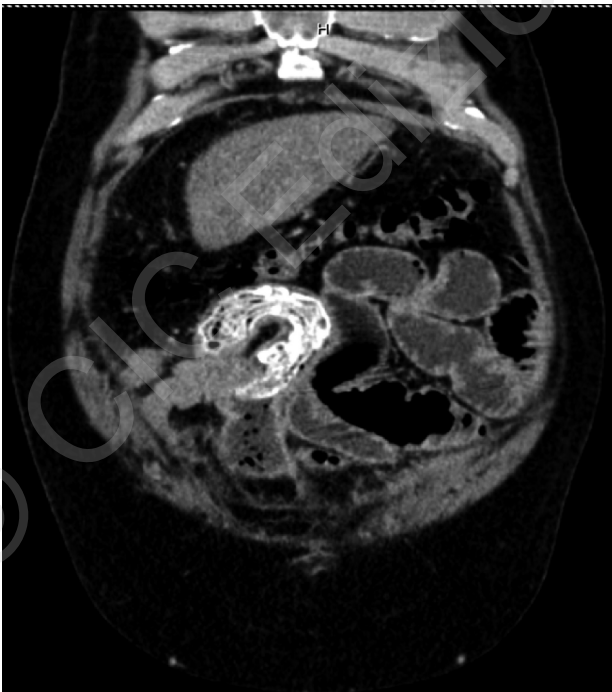
Fig. 1 - CT image showing small bowel obstruction and a hyperdense tubular material, into the gut, referring to previous surgical hernia repair with mesh.

Abdominal CT record showed: "No intra-abdominal free air. No abdomino-pelvic free fluid. Previous splenectomy. Compared to previous CTs, the solid tissue adhering to the pancreatic tail (probable island of splenosis) appears substantially unchanged. In mesogastric region, below the anterior abdominal wall, a highly hyperdense tubular material is present, inside the gut, referring to previous surgical hernia repair with mesh. The loops are quite extended upstream with some small air-fluid levels. The solid tissue fringed in the context of the abdominal wall, probably fibrotic, does not present a particular enhancement on phase contrast-enhancement. No fluid collections in its context. Appearance of multiple reactive mesenteric lymph nodes. No focal lesions or biliary dilatation. Kidney size and morphology within normal limits, with no signs of urinary stasis. No adrenal swelling. No aneurysmal dilatation of the abdominal aorta". (Fig. 1).

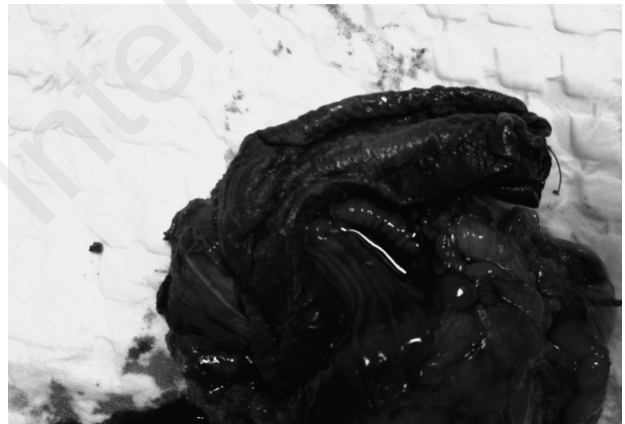
Fig. 3 - At the opening of the bowel, inside the lumen of the small intestine, is visible prosthesis that macroscopically refers to Gore-Tex® mesh (W. L. Gore & Associates, Inc. Medical Products Division, Flagstaff, Arizona).

The patient was therefore submitted to laparotomy, with detection of massive fibrosis encompassing non-resorbable mesh of previous plastic according to Rives; recognition, at the opening of the peritoneum, of the intestinal coil inseparable from the abdominal wall; en-bloc resection of intestinal coil for a total of about 70 cm and peritoneal-fascial layer, with ileal resection and latero-lateral manual double layer anastomosis. In the surgical specimen (Fig. 2) was visible, inside of the lumen of the small intestine, a prosthesis that macroscopically refers to Gore-Tex® mesh (W. L. Gore & Associates, Inc. Medical Products Division, Flagstaff, Arizona) (Fig. 3); ProTack™ 5mm Fixation Devices (Covidien Healthcare, Mansfield, MA) were also visible (Fig. 4). Laparotomy was closed *en masse* by Maxon-loop.

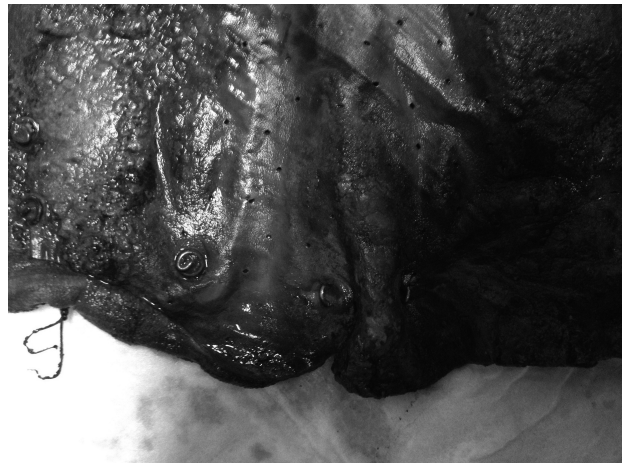
Fig. 4 - Particular of surgical specimen: ProTack™ 5mm Fixation Devices (Covidien Healthcare, Mansfield, MA).
