Test with high-energy and high-intensity proton beam on ATLAS silicon detectors towards HL-LHC

Summary. — The ATLAS silicon tracker was designed to sustain a high level of dose integrated over several years of LHC operations. The radiation tolerance should nevertheless guarantee the survival of the detector in the case of accidental beam loss. In 2006, an experiment performed on an ATLAS Pixel module established that they are able to sustain beam losses in the order of 1.5×10^{10} protons/cm² with a minimal or no performance degradation. Recently, a new experiment was performed with a higher-intensity and -energy proton beam on two IBL Pixel modules and one ITk strip in the HiRadMat area at CERN. Preliminary results are presented along with perspectives of 2018 test beams.

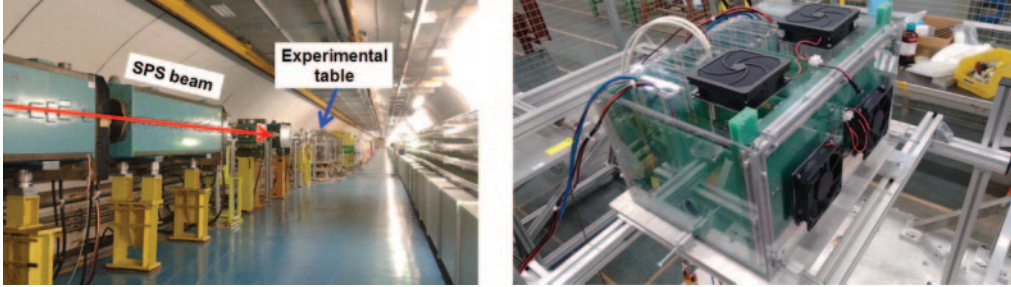
Fig. 1. – HiRadMat experimental area (TNC tunnel) and the test-box.

High-Radiation to Materials (HiRadMat) [5] is a test beam facility at CERN, designed to provide high-intensity pulsed beams to an irradiation area where material samples can be tested. The facility uses the high-energy $440 \text{ GeV}/c^2$ proton beam extracted from the CERN Super Proton Synchrotron (SPS). Each pulse is made of 1 to 288 bunches, with 25 ns separation or higher. Two parallel tunnels host the beam line with the experimental tables (TNC tunnel, fig. 1) and the read-out system (TT61 tunnel).

The experimental table held the ATLAS test-box (epoxy fiber glass, makrolon and aluminum) which was equipped with a cooling system (four fans $12 \times 12 \text{ cm}^2$, fig. 1). The three tested modules are loaded on fiber glass frames within the test-box, perpendicular with the beam.

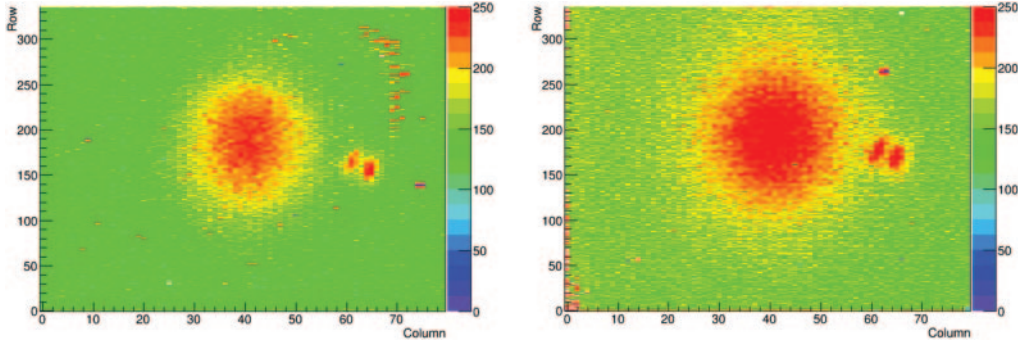
Fig. 2. – Noise maps obtained with threshold scan of IBL module 1 (left) and module 2 (right).

The noise maps obtained with Threshold scan are shown in fig. 2 for IBL modules 1 (left) and 2 (right): in both IBL modules, the noise increases in correspondence of the beam spot.

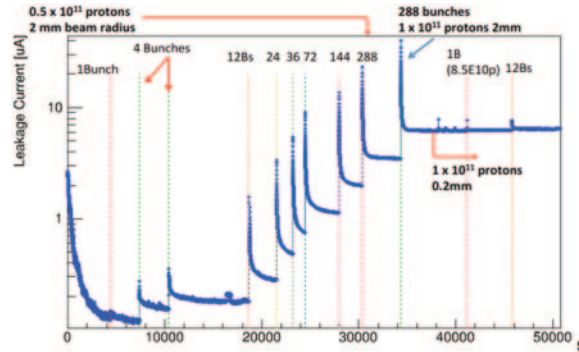
Fig. 3. – ITk strip module leakage current.

In fig. 3 we show the increase of the leakage current with global irradiation (2 mm radius) monitored on the ITk module. The increment of leakage current follows the increase of the beam intensity. No drift of leakage current was visible, even after 288 bunches.
