Excavations at Villa Magna 2006

The first season's excavation at Villa Magna initiates the investigation of both the Roman villa and the monastery built over it. Over half of the area of the villa was covered with a geophysical survey whose results give us an extraordinary preview of the structures we are studying. This report gives a brief overview of the significant results of the project, which is sponsored by the 1984 Foundation and is the result of a collaboration between the University of Pennsylvania, the British School at Rome and the Soprintendenza Archeologica del Lazio, represented by co-director Sandra Gatti.

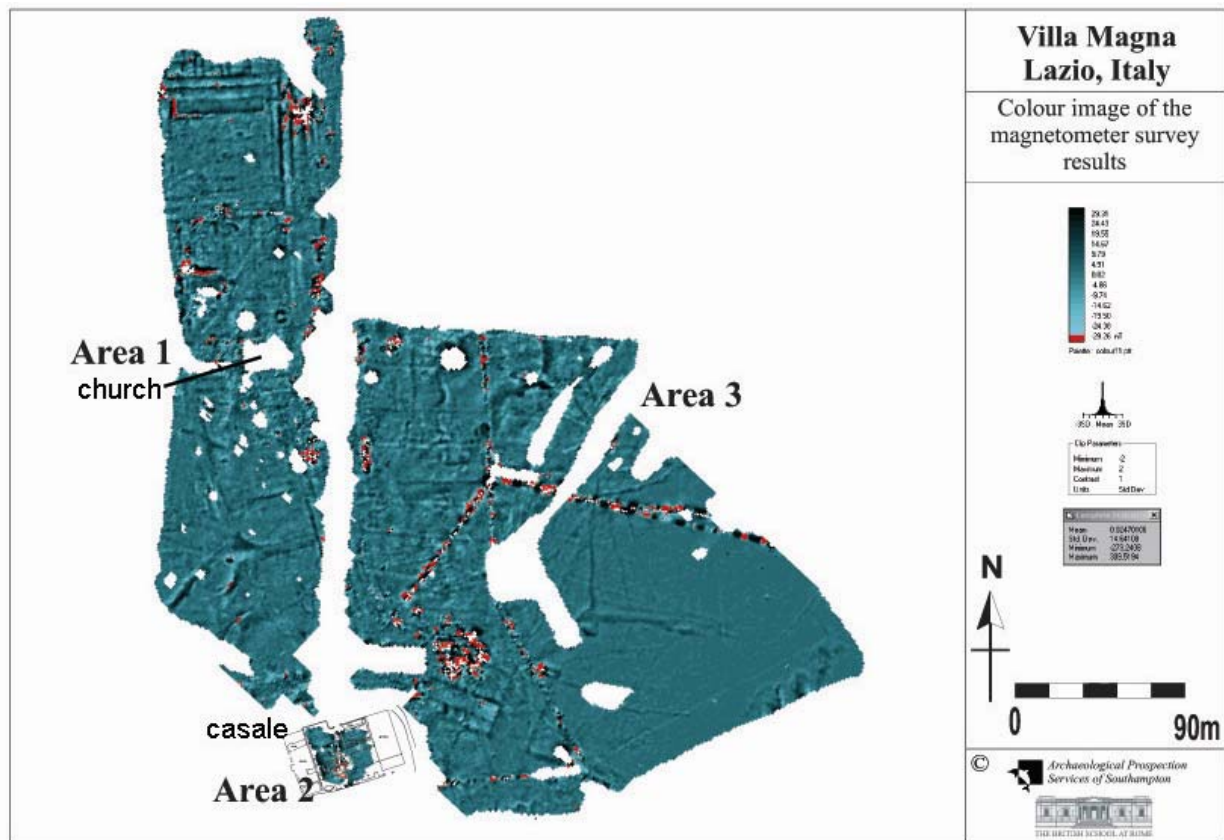
Fig. 1. Magnetometry near the villa (Sophie Hay).

The magnetometer survey conducted in 2006 at Villa Magna covered approximately 8.5 hectares. The survey covered three areas: around the church, inside the courtyard in the main casale, and the large field to the east of the casale. Overall, the results proved to be highly successful and provided a clear plan and layout of the villa and its surrounding buildings. In some areas the extent and limit of the villa complex was identified (fig. 1).

The area to the north of the church consists of a flat terrace partially bounded to the north and east by a revetment wall constructed in *opus mixtum*. The results were extremely clear in this area and a clear plan of a main body of the villa was identified which lies on a north-south alignment covering an area of about 150m x 80m. In the northernmost part of the area, the survey indicates the presence of walls very close to ground surface that probably contain courses of brick within the build. Immediately evident is the presence of a large, mainly open area measuring 60m by 60m that appears to have some internal divisions particularly along the northern edge of this feature. This open area could represent a courtyard or peristyle. Bordering a corridor or portico that surrounds this feature there are a series of small rooms to the north and east. The structure continued to the south on the same alignment and many internal divisions indicating rooms can be seen. The remains of an underground cistern stand today in the centre of the terrace and it is probable that some of the anomalies represent this construction.

The area to the south of the church rises gently towards the farmhouse. The results from this area are very interesting. The linear positive anomalies are oriented NNW-SSE; a different alignment to those north of the church. The anomalies are slightly fainter than those to the north of church suggesting that either the remains are buried more deeply or that brick was not a principle building material in this area. At least one clear structure can be determined measuring about 45m by 30m with a potential apse-like western end in the centre of the area. Linear anomalies stemming from the ends of this structure seem to indicate further buildings particularly to the north, with possible internal divisions. There are some faint traces of the continuation of this structure to the south.

The most striking results were located on the only flat ground in the south west corner of the area. Linear positive anomalies on a WSW-ESE alignment represent a long rectangular structure measuring about 40m by 20m. The north edge of this structure appears to contain small internal divisions. There may be a similar set of rooms to the south but the anomalies are very faint. Perpendicular and adjoining this construction is a larger structure (60m by 20m) lacking any internal divisions. This vast complex may relate to the cisterns that border the southern edge of the field.

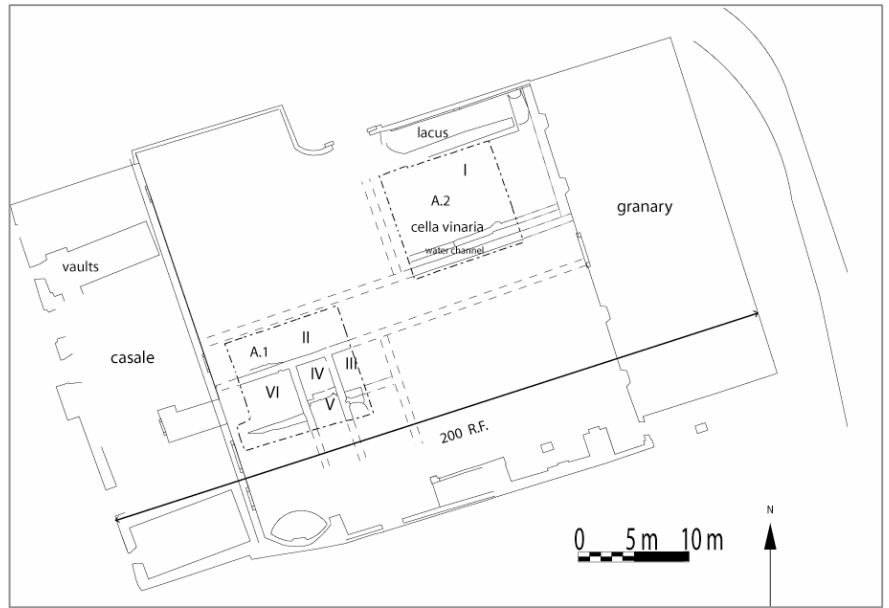
Fig. 2. Trenches in the courtyard of the casale.

Like our predecessors in the eighteenth and nineteenth century who carried out a certain amount of treasure hunting, we began our explorations in the courtyard of the casale, wide open area measuring some 30 x 30 metres (fig. 2). Here was already exposed a small stretch of *opus spicatum* pavement in yellow marble (*giallo antico* and *porta santa*), lying beside what appeared to be the base of a raised cistern. Expanding the trench to ca.10 x 10m. we exposed the entire extent of the paving, unfortunately heavily destroyed by previous interventions. However, enough was preserved to allow us to reconstruct the nature and function of the room, which was certainly a *cella vinaria* (room I).

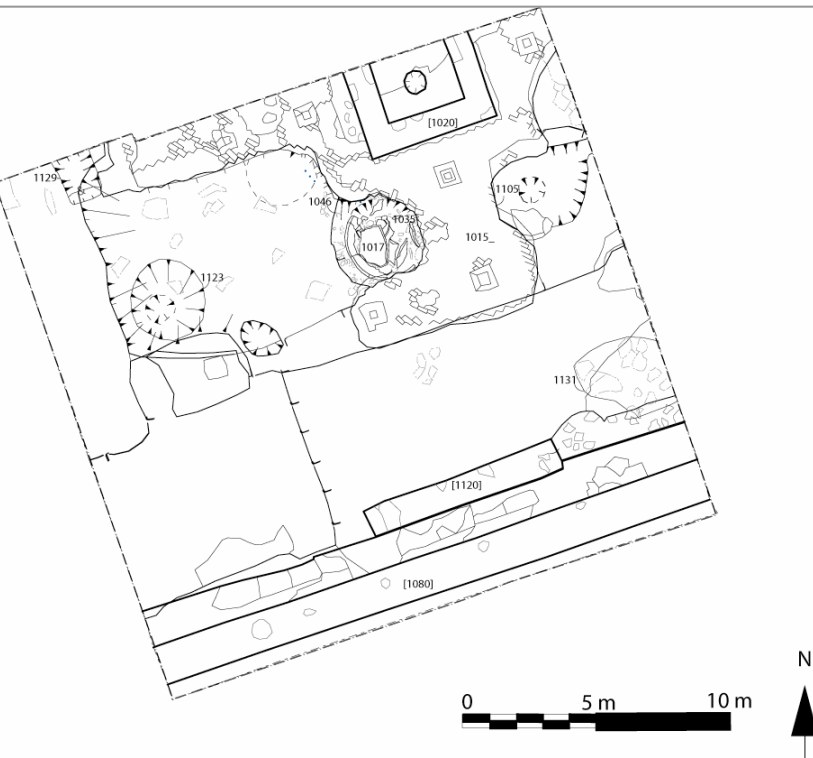
Fig. 3. Plan, Area A2.

It consists of a large rectangular space, 14 metres wide and at least 15 metres long (fig. 3). Along the north side lies the foundation of what is certainly a *lacus*, raised just under a meter over the floor surface. Below this on its south side at least one marble-lined vat, with a settling tank at its bottom, received the must from the pressed grapes. From this tank the must would have been transferred into a number of *dolia* built into the floor (figs. 4-5). Under the floor level the *dolia* were encased in yellow clay, which creates ideal conditions for the fermentation of the wine, as it prevents the contents of the *dolia* from overheating. The *opus spicatum* floor was built on a mortar preparation over the clay, connecting with the *dolia* just below their necks. At this point hydraulic *opus signinum* plaster was laid to seal the area between the marble tiles and the jars: numerous fragments of thin, curved serpentine bands of the diameter of the shoulder of the *dolia* suggest that the join was articulated with these.

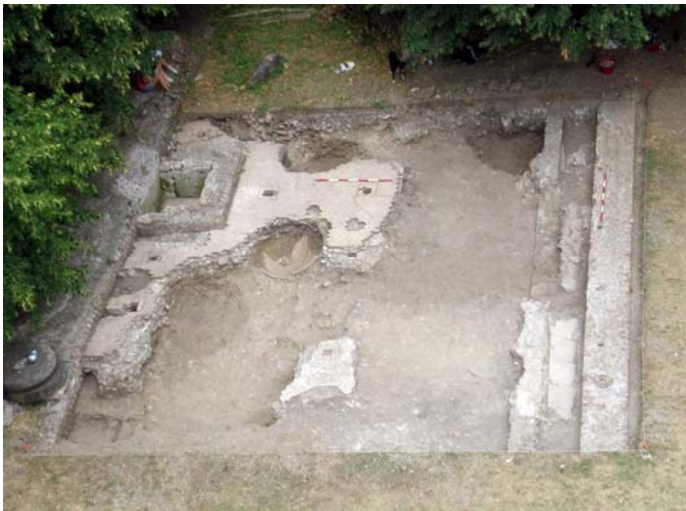
Fig. 4. Area A2: the cella vinaria.

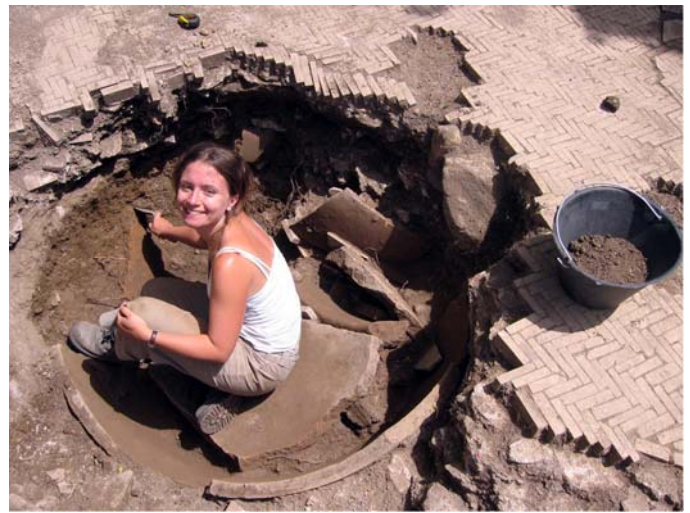
Fig. 5. Dolium and spicatum pavement in the cella vinaria.

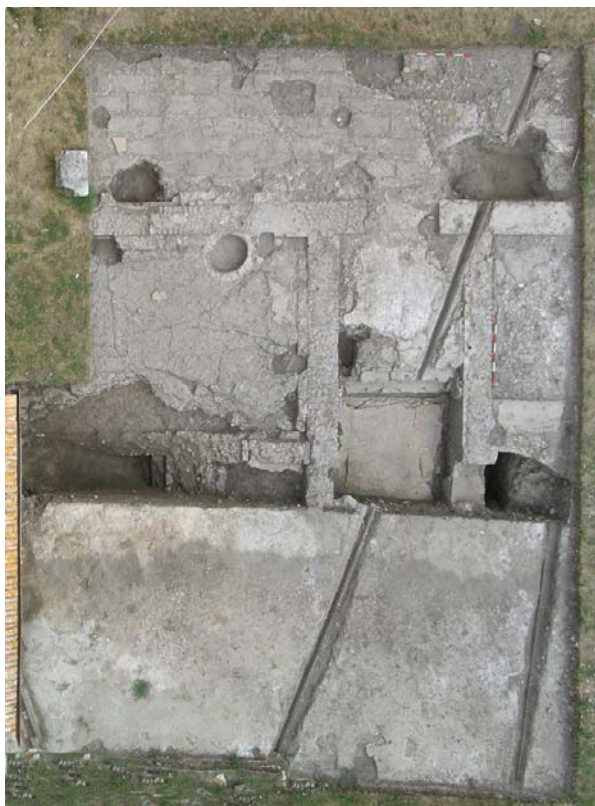
Fig. 6. Area A1.

The second trench in the cortile was somewhat larger, 16 x 12m, and placed in the diagonally opposite corner (figs. 6 and 7). Here a corridor (room II) stretching towards the *cella vinaria* was revealed, as well as a series of rooms off it. The pavements of all of these rooms have been almost completely spoliated, but enough remains to show that the corridor was floored in a simple rectangular pattern carried out in white marble with yellow veining and *pavonazzetto*, while the large room, VI, was paved in a white marble, but with a pattern of rotated squares. From this room a staircase leads down west towards the vaulted

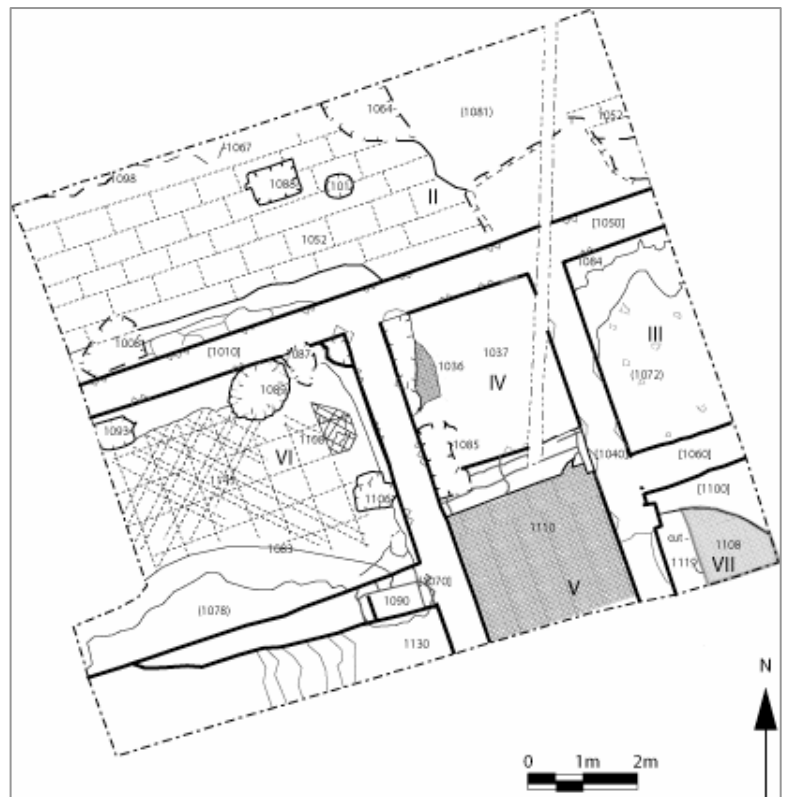
Fig. 7. Plan, Area A1.

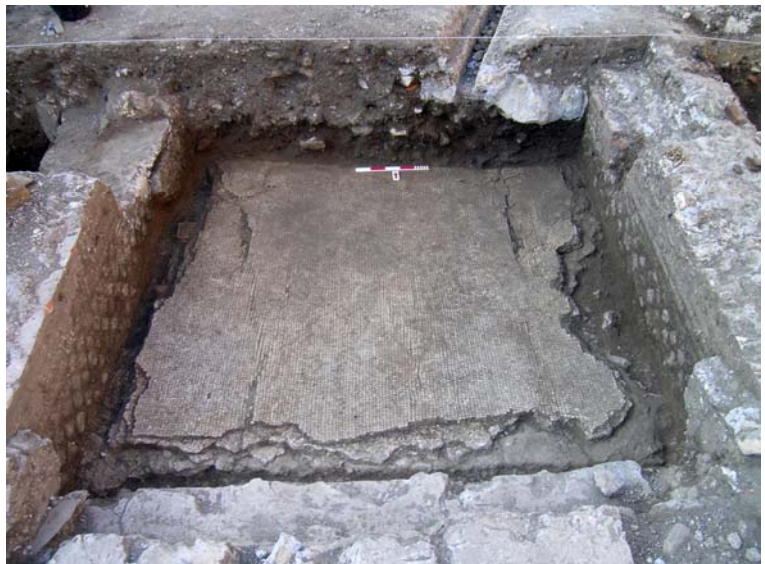
Fig. 8. Stairwell with late mosaic.

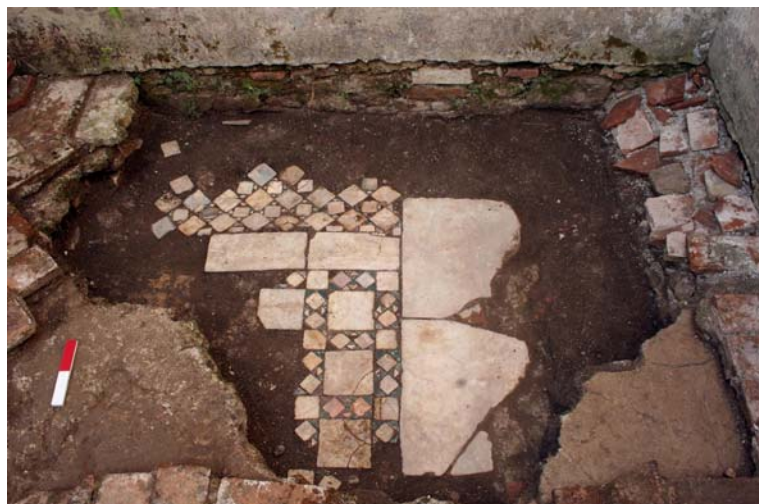
Fig. 9. Cosmatesque pavement below the modern floor.

evident traces of repair (fig. 9). The patterns and materials of the floor have strong affinities with floors in Rome (S. Clemente) and elsewhere in Lazio (the Duomo of Ferentino), both of which have been dated to the first decades of the twelfth century.² This dating indicates that there was a phase of renovations to the church prior to the reconsecration of the altar by Gregory IX, attested by an inscription of 1217, and also prior to the major projects by the Cosmati family of stoneworkers at Anagni, which took place in the 1230s–50s.³

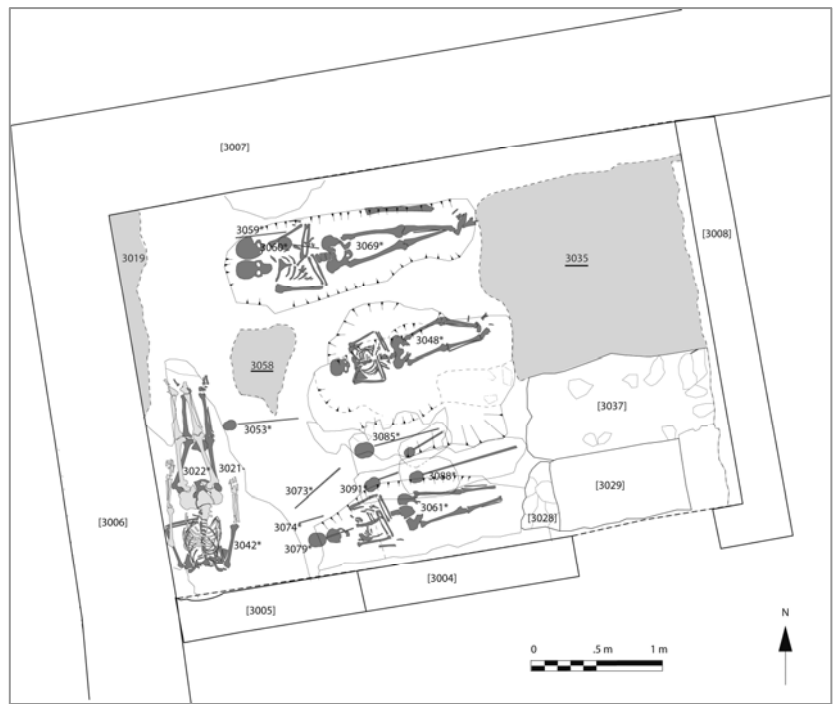
Fig. 10. Cemetery in the southwest chapel.

Excavation of the chapel revealed a plaster floor and threshold, possibly dating to the 15th century, and cut by a number of tombs (fig. 10). Similar rings on two of the skeletons suggest that this was a family chapel: in all, 6 adults and 10 babies were found there. Visible in one of the cuts is an *in-situ* column base clearly removed from the villa, which probably formed part of the arcade of

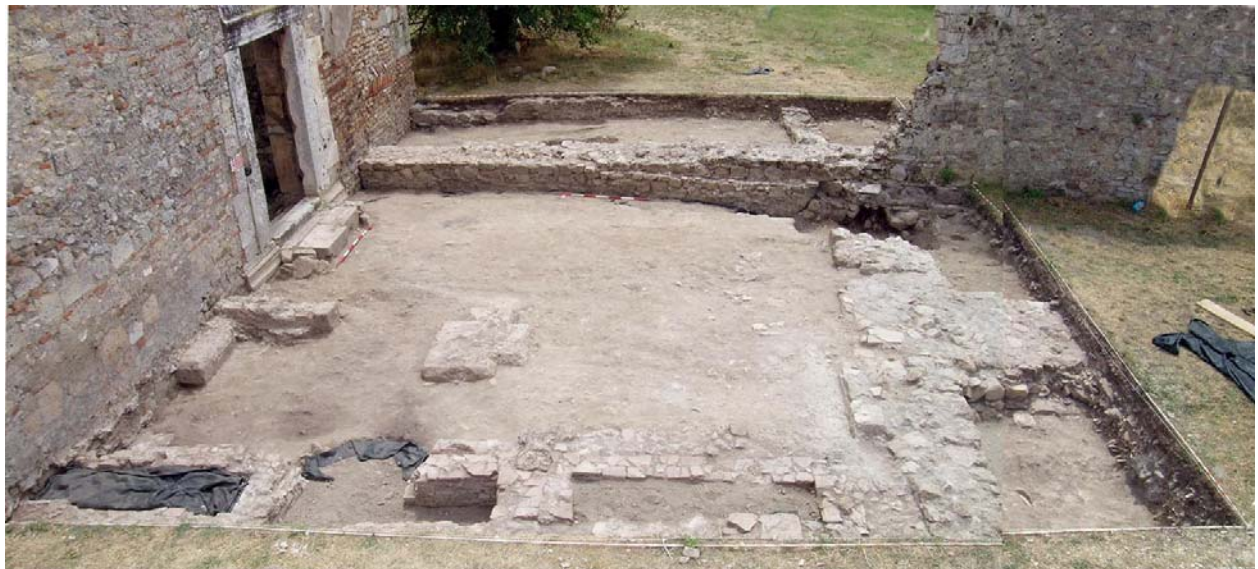
Fig 11. Excavation in front of the church of S. Pietro.

The trench in front of the church (fig. 11) has identified structures of four major phases. The most recent is the period of construction and subsequent use of the fortification wall running east-west and abutting the church (fig. 12). The construction of this fortification might have happened in the 15th century. The typology of the windows and tower suggest a dating then, and the few textual sources available to us corroborate such a dating.

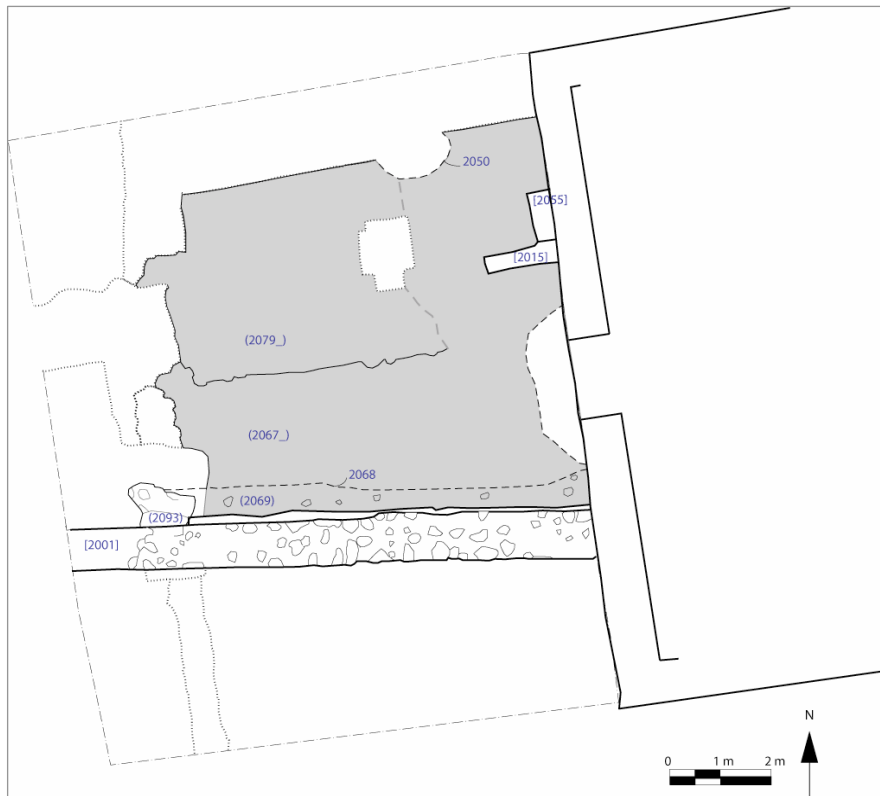
Fig. 12. Borgo wall and associated surfaces in front of the church.

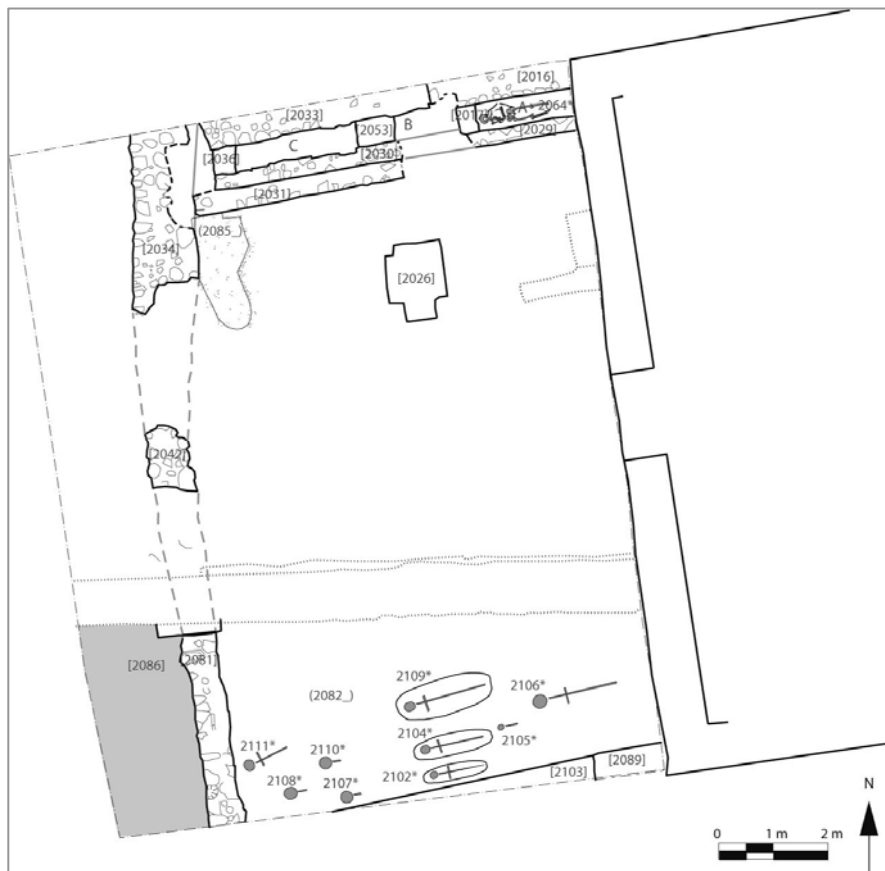
Fig. 13. The churchyard wall.

The rectangular building straddles the remains of a churchyard wall. The walls were built in different masonry, perhaps reusing earlier structures (fig. 13). Later pits and trenches in the area make clear that the churchyard was used as a cemetery. The skeletons which have been excavated are male, female, adult and child, indicating that it was a lay cemetery, not monastic, which must be located elsewhere. Along the northern side of the church yard, monumental tombs were built of stone and brick. Two of these were robbed out, but the third produced fully 6 adult burials, though no elements to suggest a date of the tombs. We anticipate a significant number of tombs to emerge from this churchyard in coming seasons.
